Inspection Report

Property Address:
123 Nice Street
Asheville, NC 28801

HomeBuyers Inspection HBI

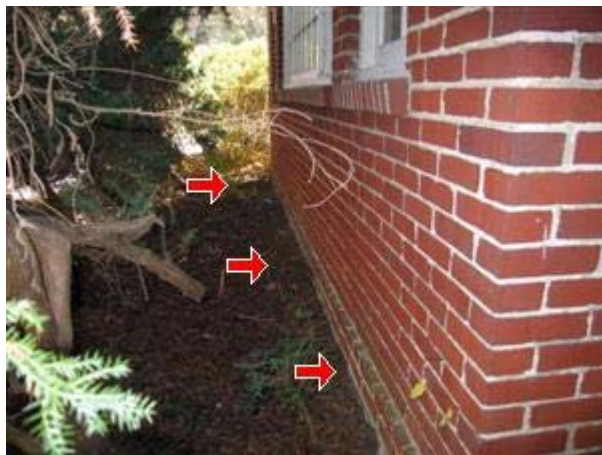
2.0 Picture 1

The Brick siding at the left side (facing front) is loose, and missing mortar. Further deterioration can occur if not corrected. A qualified contractor should inspect and repair as needed.

The Brick siding at the left side (facing front) is loose, and missing mortar. Further deterioration can occur if not corrected. A qualified contractor should inspect and repair as needed.

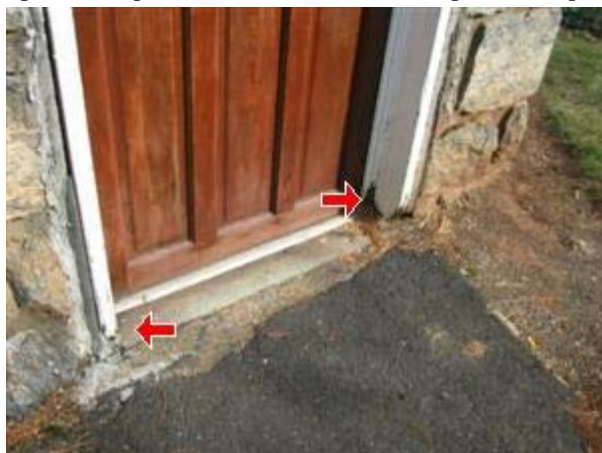
2.1 Picture 1

The main entry door at rear of home are deteriorated at bottom of jamb (s). Further deterioration may occur if not repaired. A qualified contractor should inspect and repair as needed.

The main entry door at rear of home are deteriorated at bottom of jamb (s). Further deterioration may occur if not repaired. A qualified contractor should inspect and repair as needed.

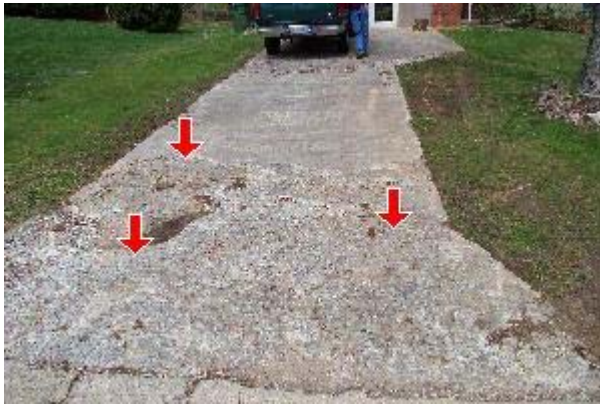
2.4 Picture 1

The concrete drive at the front of home are deteriorated in areas. A general replacement is likely. A qualified contractor should inspect and repair as needed.

The concrete drive at the front of home are deteriorated in areas. A general replacement is likely. A qualified contractor should inspect and repair as needed.

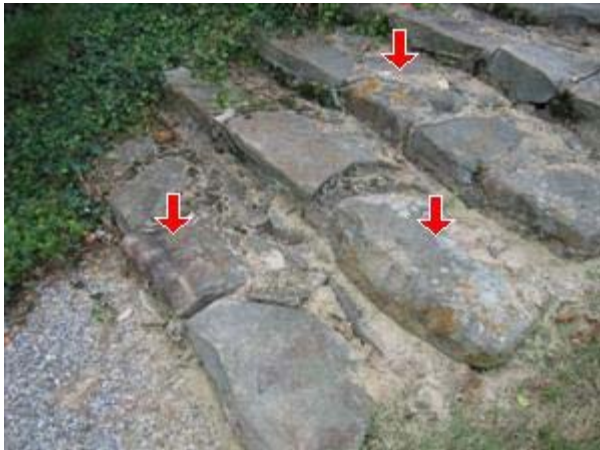
2.4 Picture 2

The rock steps at the front of home and rear of home are loose in areas. Water can cause further deterioration if not repaired and sealed properly. A qualified contractor should inspect and repair as needed.

The rock steps at the front of home and rear of home are loose in areas. Water can cause further deterioration if not repaired and sealed properly. A qualified contractor should inspect and repair as needed.

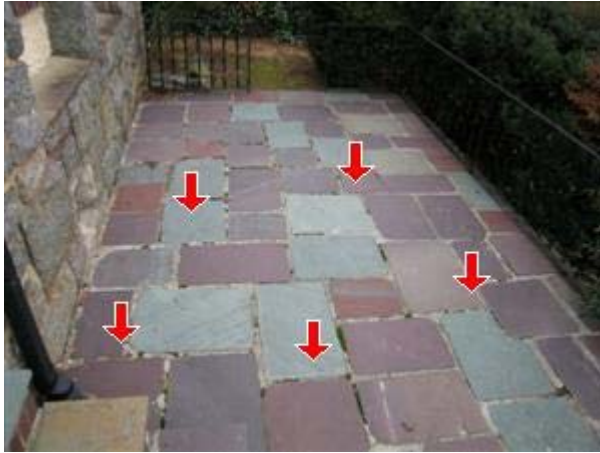
2.4 Picture 4

The slate floor on the patio at the front of home has deteriorated mortar or grout, and is loose and uneven in areas. A general replacement is likely. A qualified contractor should inspect and repair as needed.

The slate floor on the patio at the front of home has deteriorated mortar or grout, and is loose and uneven in areas. A general replacement is likely. A qualified contractor should inspect and repair as needed.

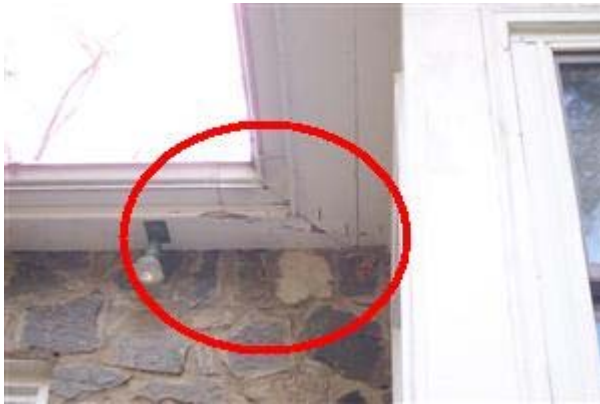
2.5 Picture 1

The soffit panel at eave on the front of home are weathered and beginning to deteriorate and peeling paint. Further deterioration may occur if not repaired. A qualified contractor should inspect and repair as needed.

The soffit panel at eave on the front of home are weathered and beginning to deteriorate and peeling paint. Further deterioration may occur if not repaired. A qualified contractor should inspect and repair as needed.

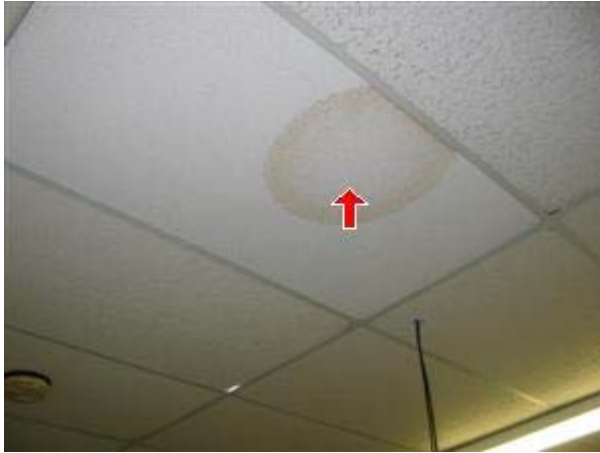
4.0 Picture 1

The Ceiling Tile on the ceiling reveals a water stain indicating a leak did or still exists at the Kitchen. Repairs are needed. A qualified contractor should inspect and repair as needed.

The Ceiling Tile on the ceiling reveals a water stain indicating a leak did or still exists at the Kitchen. Repairs are needed. A qualified contractor should inspect and repair as needed.

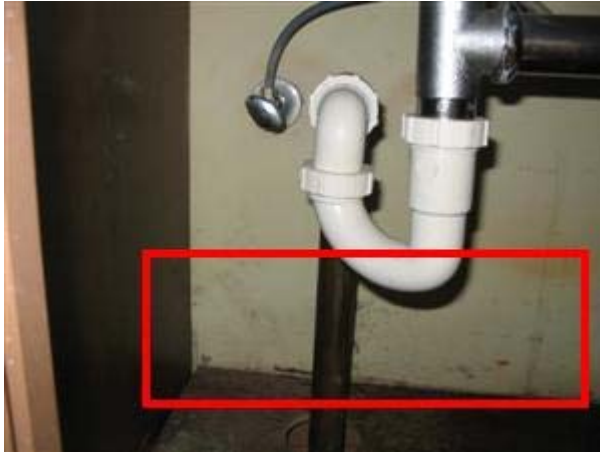
4.1 Picture 1

Signs of fungi growth is present on the interior wall of kitchen cabinetry in several areas. We did not inspect, test or determine if this growth is or is not a health hazard. The underlying cause is moisture. I recommend you contact a mold inspector or expert for investigation or correction if needed.

Signs of fungi growth is present on the interior wall of kitchen cabinetry in several areas. We did not inspect, test or determine if this growth is or is not a health hazard. The underlying cause is moisture. I recommend you contact a mold inspector or expert for investigation or correction if needed.

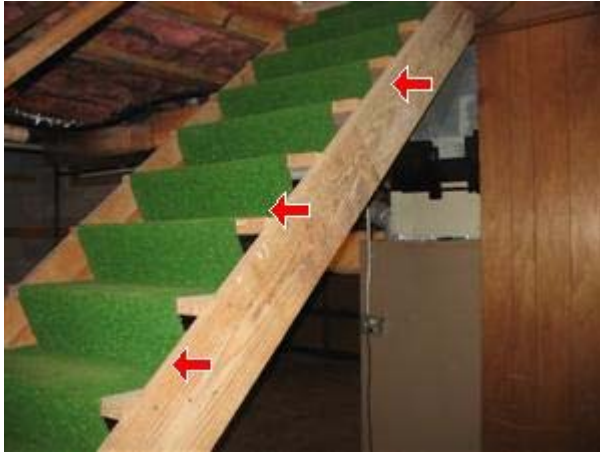
4.3 Picture 1

The hand/guard rail for the stairs to basement is missing and are missing pickets. Also the stringers are not built properly and treads are not supported properly. A fall or injury could occur if not corrected. A qualified contractor should repair or replace as needed.

The hand/guard rail for the stairs to basement is missing and are missing pickets. Also the stringers are not built properly and treads are not supported properly. A fall or injury could occur if not corrected. A qualified contractor should repair or replace as needed.

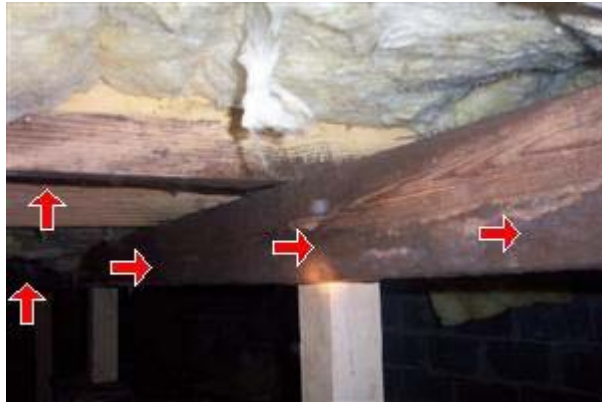
5.3 Picture 1

Signs of fungi growth is present on the floor system in crawlspace in several areas. We did not inspect, test or determine if this growth is or is not a health hazard. The underlying cause is moisture. I recommend you contact a mold inspector or expert for investigation or correction if needed.

Signs of fungi growth is present on the floor system in crawlspace in several areas. We did not inspect, test or determine if this growth is or is not a health hazard. The underlying cause is moisture. I recommend you contact a mold inspector or expert for investigation or correction if needed.

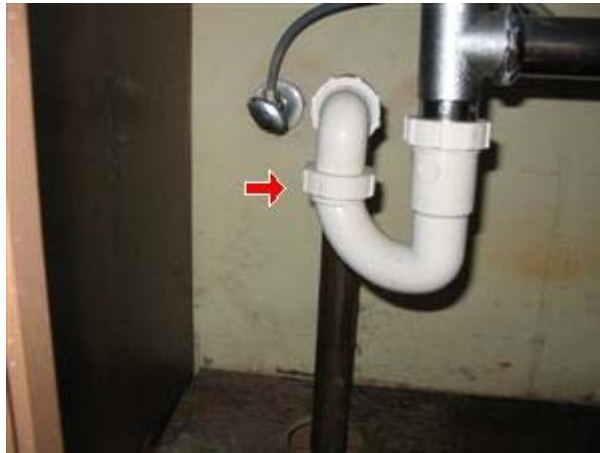
6.0 Picture 1

The waste line has a S-trap, and should be changed to a P-trap and "Auto-vent" at the Kitchen sink. This is not considered up to today's standard. A qualified licensed plumber should repair or correct as needed.

The waste line has a S-trap, and should be changed to a P-trap and "Auto-vent" at the Kitchen sink. This is not considered up to today's standard. A qualified licensed plumber should repair or correct as needed.

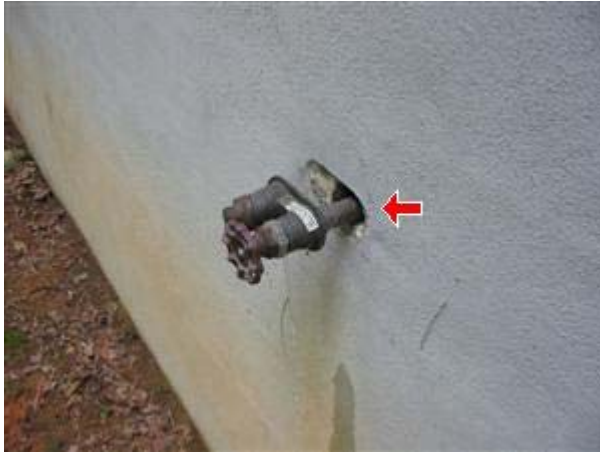
6.1 Picture 1

The outside water faucets are loose, and needs securing to wall and leaks when turned on and leaks at vacuum breaker at the left side (facing front) and right side (facing front). Repairs are needed. A qualified licensed plumber should repair or correct as needed.

The outside water faucets are loose, and needs securing to wall and leaks when turned on and leaks at vacuum breaker at the left side (facing front) and right side (facing front). Repairs are needed. A qualified licensed plumber should repair or correct as needed.

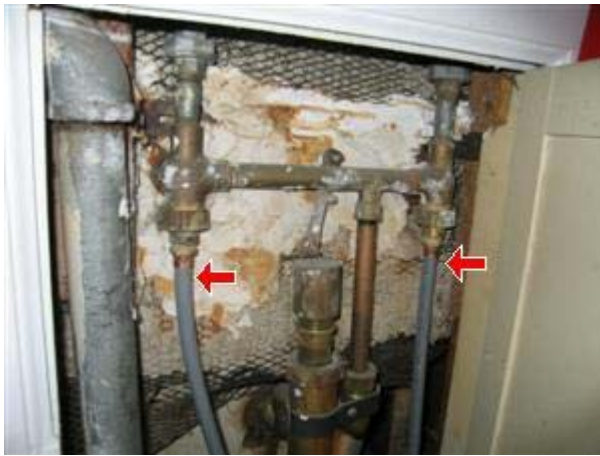
6.1 Picture 3

Polybutylene plastic plumbing supply lines (PB) are installed in the subject house. Polybutylene has been used in this area for many years, but has had a higher than normal failure rate, and is no longer being widely used. Copper and Brass fittings used in later years have apparently reduced the failure rate. This subject house has copper fittings. For further details contact the Consumer Plumbing Recovery center at 1-800-392-7591 or the web at <http://www.pbpipe.com>

Polybutylene plastic plumbing supply lines (PB) are installed in the subject house. Polybutylene has been used in this area for many years, but has had a higher than normal failure rate, and is no longer being widely used. Copper and Brass fittings used in later years have apparently reduced the failure rate. This subject house has copper fittings. For

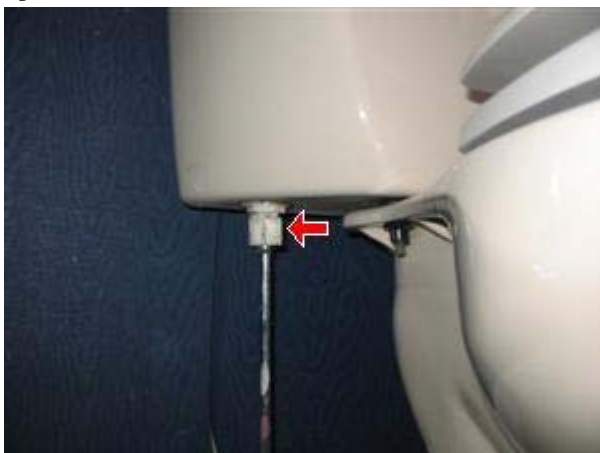
6.1 Picture 5

The water supply line for toilet is leaking at the guest bath. Repairs are needed. A qualified licensed plumber should repair or correct as needed.

The water supply line for toilet is leaking at the guest bath. Repairs are needed. A qualified licensed plumber should repair or correct as needed.

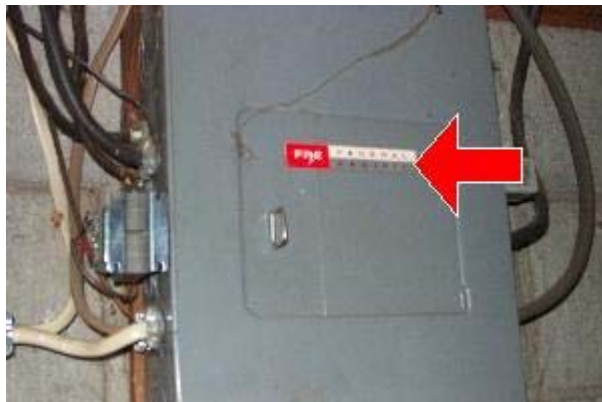
7.2 Picture 1

You have a Federal Pacific panel which is legal, but there is a possibility that the circuit breakers may not trip when shorted possibly causing an electrical hazard. Opinions by licensed electricians on this panel varies between safe and unsafe. I recommend you consult a licensed electrician for an opinion and correct if necessary.

You have a Federal Pacific panel which is legal, but there is a possibility that the circuit breakers may not trip when shorted possibly causing an electrical hazard. Opinions by licensed electricians on this panel varies between safe and unsafe. I recommend you consult a licensed electrician for an opinion and correct if necessary.

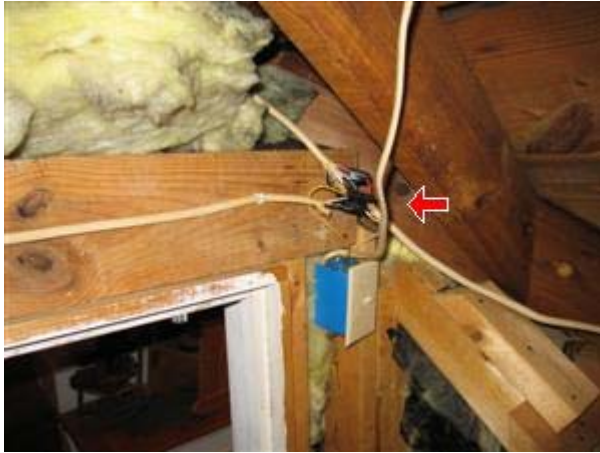
7.3 Picture 1

One loose wire splice and One loose wire end need placing in boxes with cover-plates within "Five feet" of attic access and above the Guest bath in attic. Electrical issues are considered a hazard until repaired. I recommend a qualified licensed electrician correct.

One loose wire splice and One loose wire end need placing in boxes with cover-plates within "Five feet" of attic access and above the Guest bath in attic. Electrical issues are considered a hazard until repaired. I recommend a qualified licensed electrician correct.

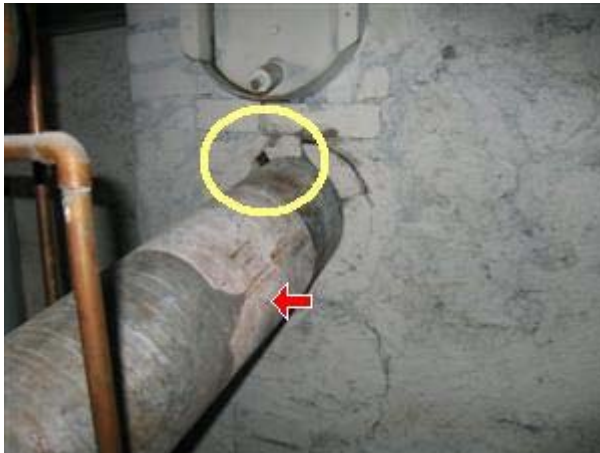
8.5 Picture 1

The vent pipe for oil fired boiler needs mastic sealed around pipe where it enters chimney. There is also a possibility of asbestos on the vent pipe. This is a safety issue and should be repaired. I recommend a qualified licensed heat contractor inspect further and repair as needed.

The vent pipe for oil fired boiler needs mastic sealed around pipe where it enters chimney. There is also a possibility of asbestos on the vent pipe. This is a safety issue and should be repaired. I recommend a qualified licensed heat contractor inspect further and repair as needed.

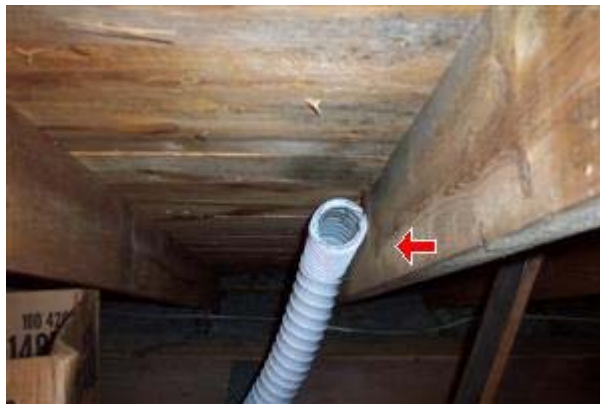
9.4 Picture 1

The Exhaust fan does not vent to outside at the guest bath. Vent pipes should terminate outside and not in the attic. Many homes have their vent pipe poised at the roof vent such as yours. It is up to you to determine whether or not this is a concern or needs further consideration from a general contractor. A qualified contractor should inspect and repair as needed.

The Exhaust fan does not vent to outside at the guest bath. Vent pipes should terminate outside and not in the attic. Many homes have their vent pipe poised at the roof vent such as yours. It is up to you to determine whether or not this is a concern or needs further consideration from a general contractor. A qualified contractor should inspect and repair as needed.
