# Inspection Report

**Property Address:**  
123 Nice Street  
Asheville, NC 28801

## HomeBuyers Inspection HBI

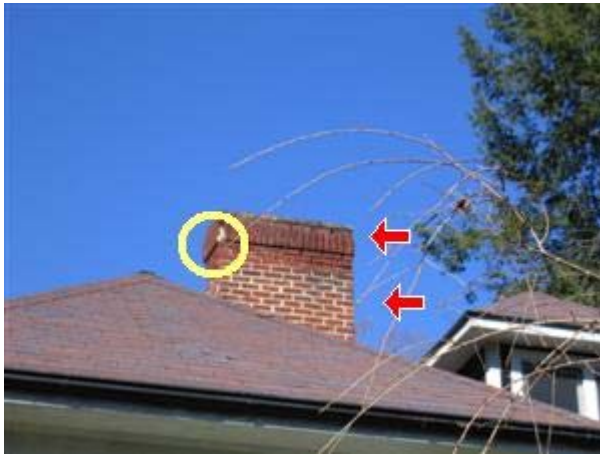
1.2 Picture 1

The brick chimney has loose mortar and missing bricks. Further deterioration may occur if not repaired. A qualified contractor should inspect and repair as needed.

The brick chimney has loose mortar and missing bricks. Further deterioration may occur if not repaired. A qualified contractor should inspect and repair as needed.

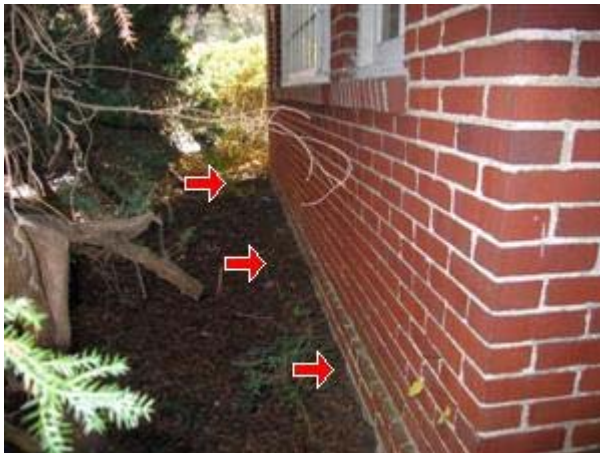
2.0 Picture 1

The Brick siding at the left side (facing front) is loose, and missing mortar. Further deterioration can occur if not corrected. A qualified contractor should inspect and repair as needed.

The Brick siding at the left side (facing front) is loose, and missing mortar. Further deterioration can occur if not corrected. A qualified contractor should inspect and repair as needed.

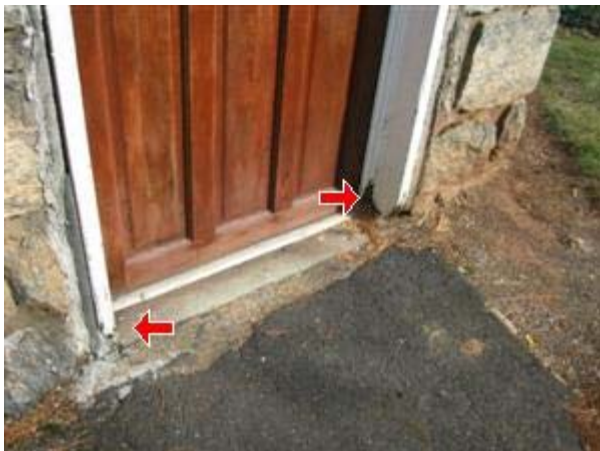
## 2.1 Picture 1

The main entry door at rear of home are deteriorated at bottom of jamb (s). Further deterioration may occur if not repaired. A qualified contractor should inspect and repair as needed.

The main entry door at rear of home are deteriorated at bottom of jamb (s). Further deterioration may occur if not repaired. A qualified contractor should inspect and repair as needed.

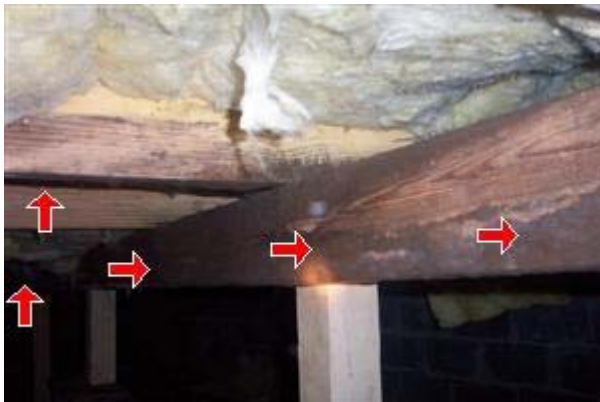
5.3 Picture 1

Signs of fungi growth is present on the floor system in crawlspace in several areas. We did not inspect, test or determine if this growth is or is not a health hazard. The underlying cause is moisture. I recommend you contact a mold inspector or expert for investigation or correction if needed.

Signs of fungi growth is present on the floor system in crawlspace in several areas. We did not inspect, test or determine if this growth is or is not a health hazard. The underlying cause is moisture. I recommend you contact a mold inspector or expert for investigation or correction if needed.

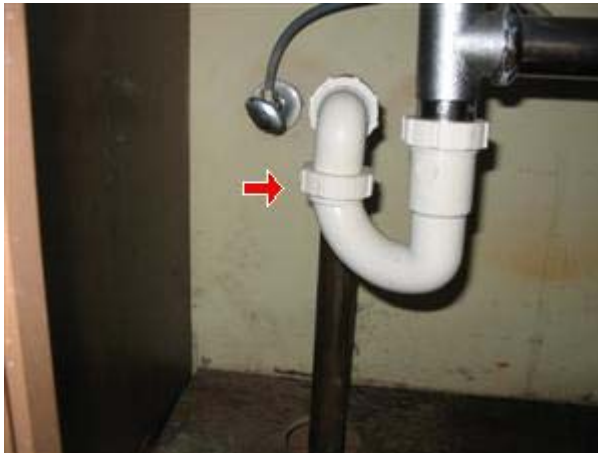
6.0 Picture 1

The waste line has a S-trap, and should be changed to a P-trap and "Auto-vent" at the Kitchen sink. This is not considered up to today's standard. A qualified licensed plumber should repair or correct as needed.

The waste line has a S-trap, and should be changed to a P-trap and "Auto-vent" at the Kitchen sink. This is not considered up to today's standard. A qualified licensed plumber should repair or correct as needed.

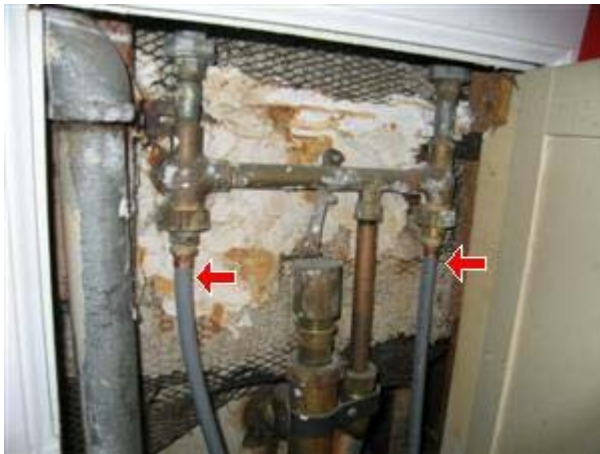
6.1 Picture 3

Polybutylene plastic plumbing supply lines (PB) are installed in the subject house. Polybutylene has been used in this area for many years, but has had a higher than normal failure rate, and is no longer being widely used. Copper and Brass fittings used in later years have apparently reduced the failure rate. This subject house has copper fittings. For further details contact the Consumer Plumbing Recovery center at 1-800-392-7591 or the web at <http://www.pbpipe.com>

Polybutylene plastic plumbing supply lines (PB) are installed in the subject house. Polybutylene has been used in this area for many years, but has had a higher than normal failure rate, and is no longer being widely used. Copper and Brass fittings used in later years have apparently reduced the failure rate. This subject house has copper fittings. For

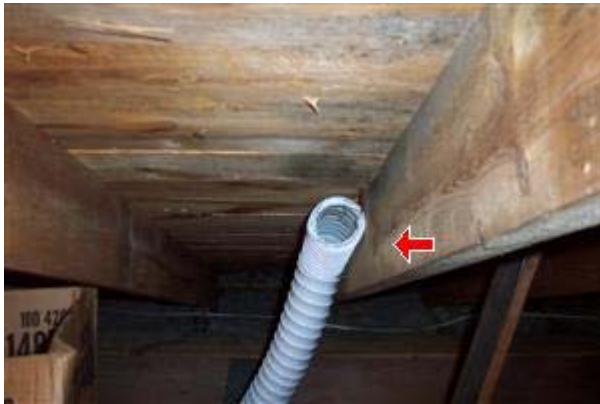
9.4 Picture 1

The Exhaust fan does not vent to outside at the guest bath. Vent pipes should terminate outside and not in the attic. Many homes have their vent pipe poised at the roof vent such as yours. It is up to you to determine whether or not this is a concern or needs further consideration from a general contractor. A qualified contractor should inspect and repair as needed.

The Exhaust fan does not vent to outside at the guest bath. Vent pipes should terminate outside and not in the attic. Many homes have their vent pipe poised at the roof vent such as yours. It is up to you to determine whether or not this is a concern or needs further consideration from a general contractor. A qualified contractor should inspect and repair as needed.
